Audi A4 8E, A6 4F, A8 4E - Repair of a Worn Propeller Schaft Center Support Mount without Dissassembly of the Shaft

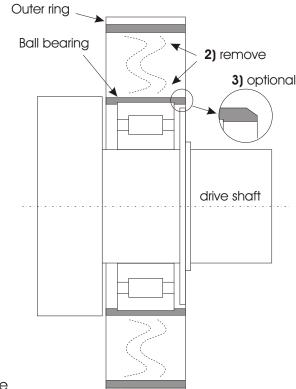
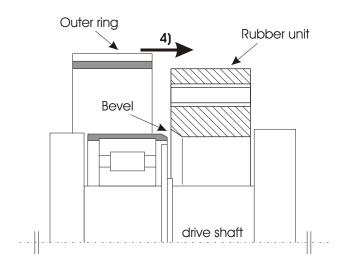
- 1) Loosen center support mount outer ring from the car.
- 2) Remove/cut off rubber remains from the outer ring and from the ball bearing. Keep rubber layer (1-2mm) on the ball bearing outer race and rubber inlay (2-3mm) on the outer ring to ensure the repair kit fits with correct tension.
- 3) **Option**: The rubber at the rim of the ball bearing may be trimmed to a slight chamfer.
- 4) Put the new rubber unit around the the drive shaft between the roller bearing and the CV-joint Opening on top! Bevel facing toward the ball bearing! and position it into the outer ring.
- 5) Install all 6 tie straps to attach the rubber unit to the outer ring, heads facing fwd or aft (see figure).
- 6) Move the whole assy over the bearing. Start on top. Silicone spray may help (before you start trimming the rubber layer at the ball bearing). Finally align the unit with the bearing.

7) Re-install center support mount on the car.
